### **Haws øye/ansiktsdusj, modell 7261 Axion**

**Model 7261 Axion Pedestal Eye Wash**

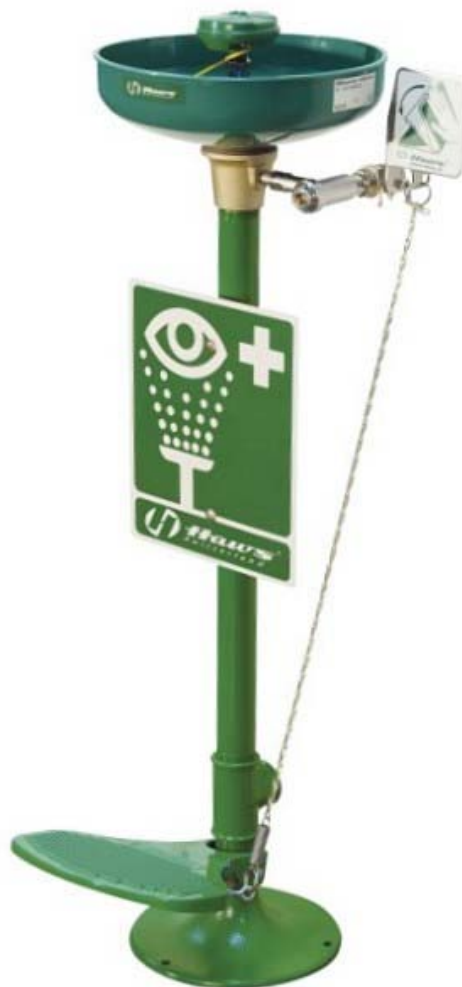
Anslutning: DN 15 – ½" RG

Vannmengde: 14 l/min.

Avløp: 32 mm

Skål og spylemunnstykke i kjemikaliebestandig ABS-plast.

Betjeningshendel i rustfritt stål.

Rør i varmgalvanisert stål, pulverlakkert med førstehjelpsgrønn farge.

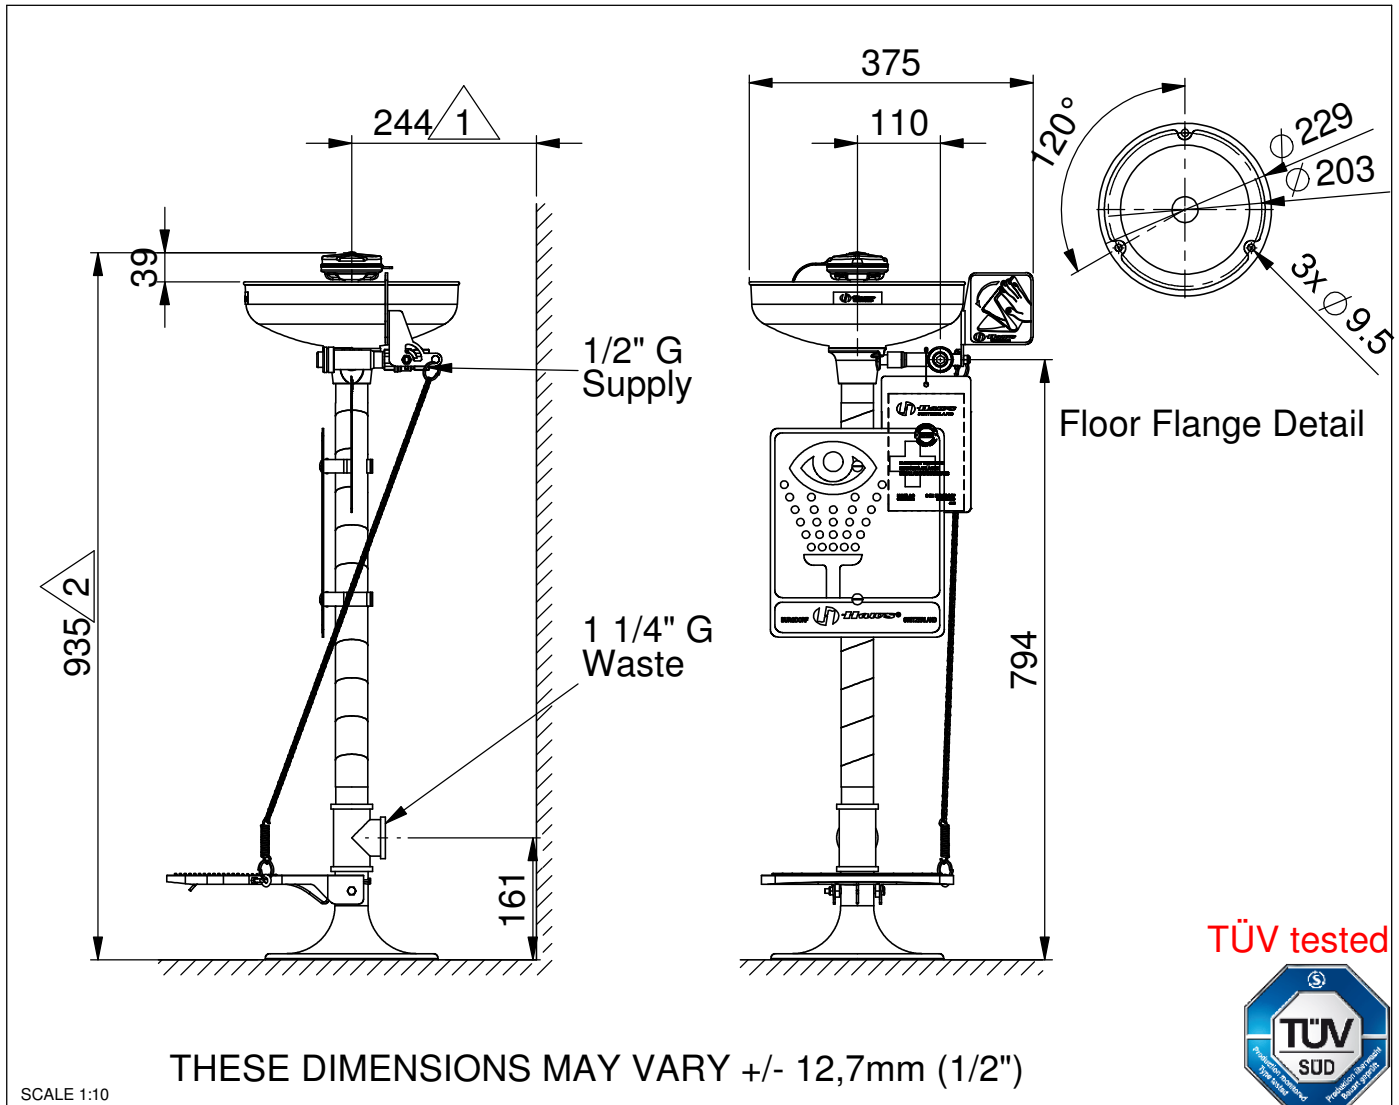
**Legally-stipulated dimensions:**

Ensure that there is a minimum clearance of 150mm (6") with respect to the nearest wall or obstacle.
-

Height above floor level: 800mm - 1200mm (2' 7 1/2" - 3' 11 1/4").

Free access to the eyewash station 7261 Axion must be guaranteed all times. The operator is responsible for the observance of this requirement.

**Connection conduit:** You are recommended to use a 1/2" G conduit, capable of withstanding pressures of 2 - 6 BAR (30 - 90 PSI). The use of an inlet filter designed to prevent the entry of suspended particles and other impurities is also recommended.
